# **EXPERIMENTAL MANURE HANDLING SYSTEMS FOR REDUCING AIRBORNE CONTAMINATION**

A Thesis Submitted to the College of  
Graduate Studies and Research  
in Partial Fulfillment of the Requirements  
for the Degree of Master of Science  
in the Department of Agricultural and Bioresource Engineering  
University of Saskatchewan  
Saskatoon

By  
Karen Stewart

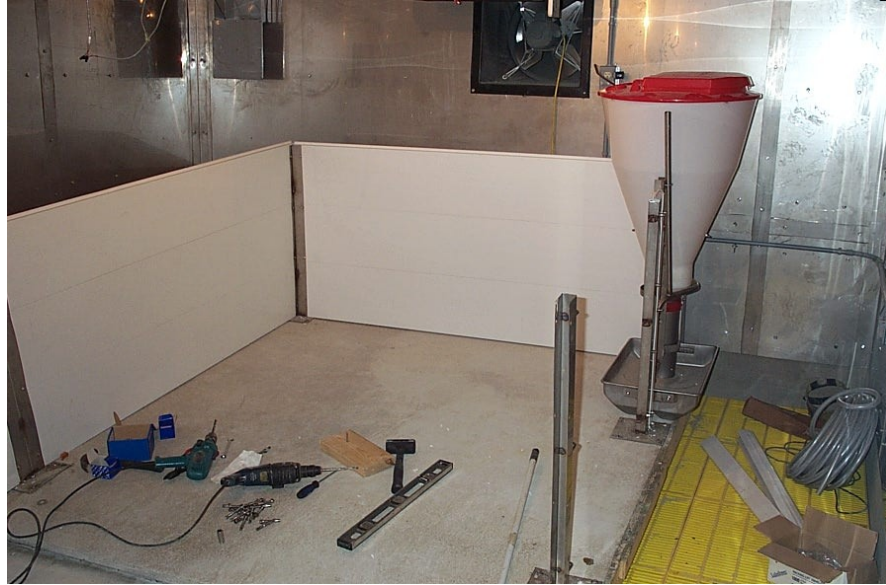
Plastic matrix flooring on fiberglass beams (Matrix Gold NR2424, Matrix Ag Inc., Calgary, Canada) that could be installed or removed in sections was used to make raised slatted floors 0.61 m above the concrete floor of the chamber (Fig. 2). Sections of this plastic flooring were removed in both chambers, allowing space for the washing gutter to be installed in one chamber and the inclined conveyor belt in the other. Plywood sheets (2 cm thick) covered by a 5 cm layer of concrete were set on supports on the slatted floors to produce sloped (8% grade) solid flooring in the areas of the pens not used for dunging. Penning was added to give each chamber the same amount of solid concrete flooring (2.13 x 2.13 m), and the same amount of dunging area (2.13 x 1.22 m) in the pens. These pens were sized for 10 grower pigs, providing each with 0.7 m<sup>2</sup> of floor space. This is more than the minimum 0.5 m<sup>2</sup> per grower pig recommended in Canadian Farm Buildings Handbook (Agriculture Canada, 1988) for solid floor pens for pigs under 45 kg.

**Figure 2 Construction details in washing gutter chamber showing flooring and penning.**

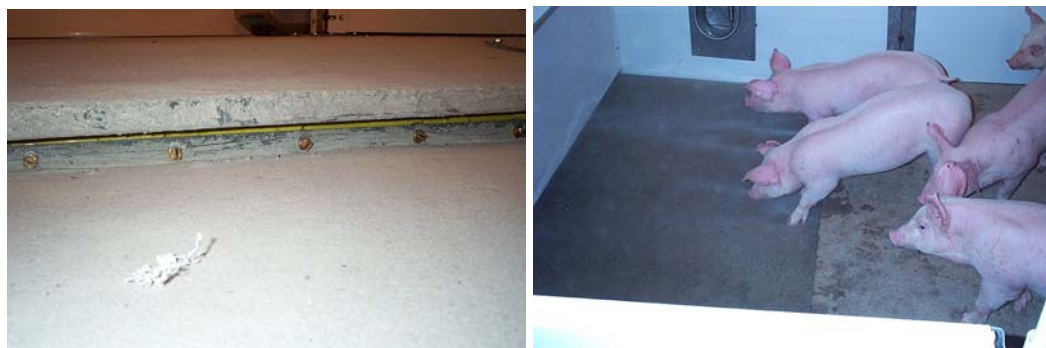
plywood holding 4 cm concrete as a table top (Figs. 3 and 4). Twelve nozzles (6 mm, brass 110° fan spray) were mounted (equally spaced) on a steel plate at the edge of the table top. These nozzles directed pressurized heated wash water parallel to the table top over the dunging area. The wash water came from the boiler supplying heated (to approximately 43°C) water to the barn, and was pressurized using a booster pump (Goulds Pumps 10GB20, ITT Industries, White Plains, NY, USA with a 2 cm Penn Flow Switch) to approximately 1.4 MPa.

a) Nozzles for the washing gutter      b) Operation of the nozzles

**Figure 4** Washing gutter used as a dunging area.
